VILLAGE OF
STIRLING
NATIONAL HISTORIC SITE

VILLAGE OF STIRLING INFRASTRUCTURE MASTER PLAN

Date: September 15, 2020

Project #: 1407-001-00

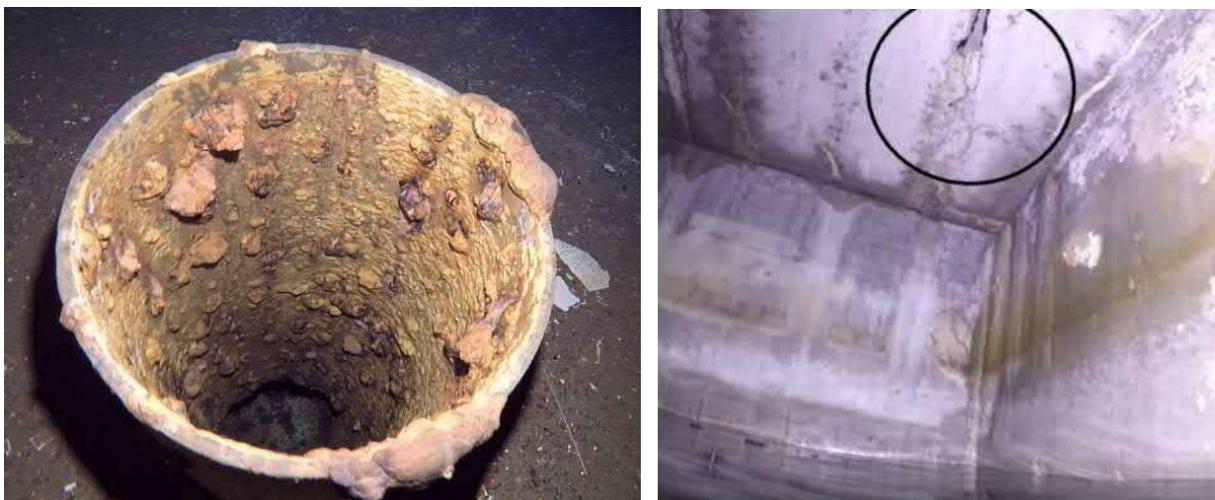
Figure 3.2 – Stirling Potable Water Reservoir – Video Inspection Photos

- The reservoir had an average amount of settlement and debris along the floor of the reservoir. Cleaning should be scheduled in 1 to 2 years,
- Concrete cover on reinforcing steel is minimal along locations of the reservoir walls. This could lead to deterioration in the structural integrity of the walls,
- A large crack is noticeable in the ceiling of the reservoir. The crack needs further investigation to determine the severity of the damage and potential repairs required,
- Piping within the reservoir has significant scaling and corrosion and should be scheduled for cleaning the next time the reservoir is drained.

A structural assessment of the potable water reservoir is recommended to determine the extent of the cracking in the ceiling, deterioration of the reinforcing steel, and identify concerns not noticeable in the videos.

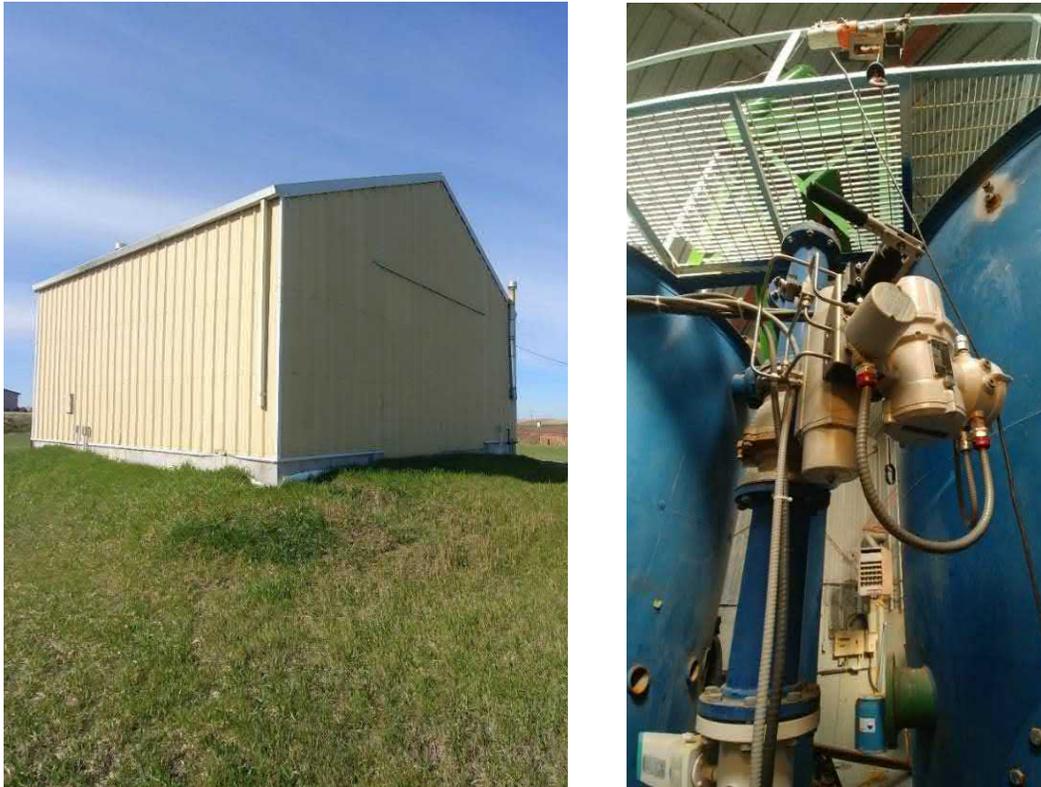
Figure 3.3 – Stirling Water Plant Facility and Piping

Adjacent to the potable water reservoir is the old WTP building that encompasses the reservoir fill control piping and communications with Raymond’s WTP. The buildings age, and large size lead to significant operation and maintenance costs for the minimal amount of equipment within. A smaller, more energy efficient alternative would be appropriate for the reservoir fill control equipment.

An optional upgrade that the Village may consider as well, is the replacement of the old WTP building with a smaller enclosure to reduce maintenance costs associated with the fill piping at the potable water reservoir. Figure 3.8, below, shows an example of a smaller enclosure that would be suitable for housing the equipment currently located in the large, unused building.

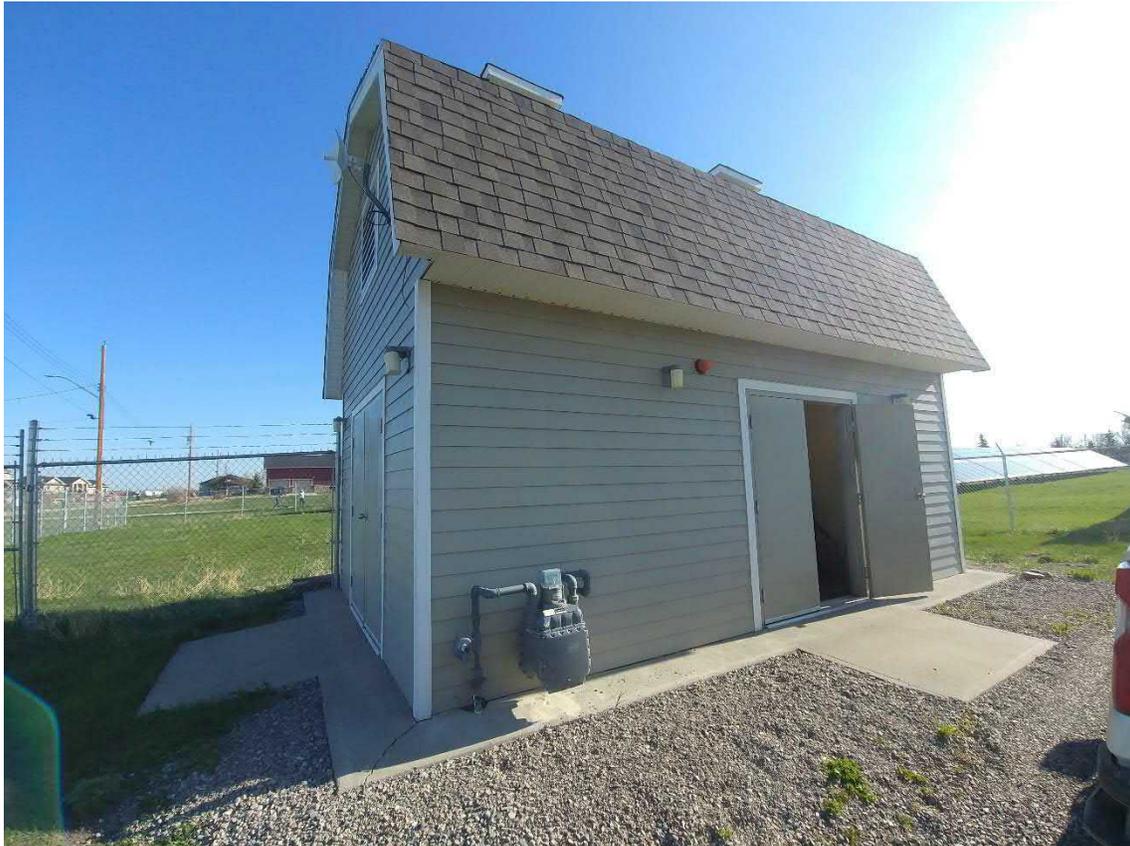
Figure 4.3 – Village Wastewater Lift Station

The lift station was constructed in 2006 and consists of a pump building and exterior concrete wet well. The pump building contains the pumps, control system and back-up power generator; the building is constructed of wood framing supported by a shallow concrete foundation. The roof structure consists of wood trusses with asphalt shingles on the exterior and gypsum board on the interior ceiling. The main floor is a combination of fibreglass reinforced plastic (FRP) grating and a concrete slab on grade where the generator sits. A concrete dry well sits below grade and contains the pumps. The concrete flooring and walls inside the building have been epoxy coated and appear in good condition. Some cracks on the exterior concrete apron around the building were observed. The stairs, handrails, grating, and cladding appear to be in good condition.

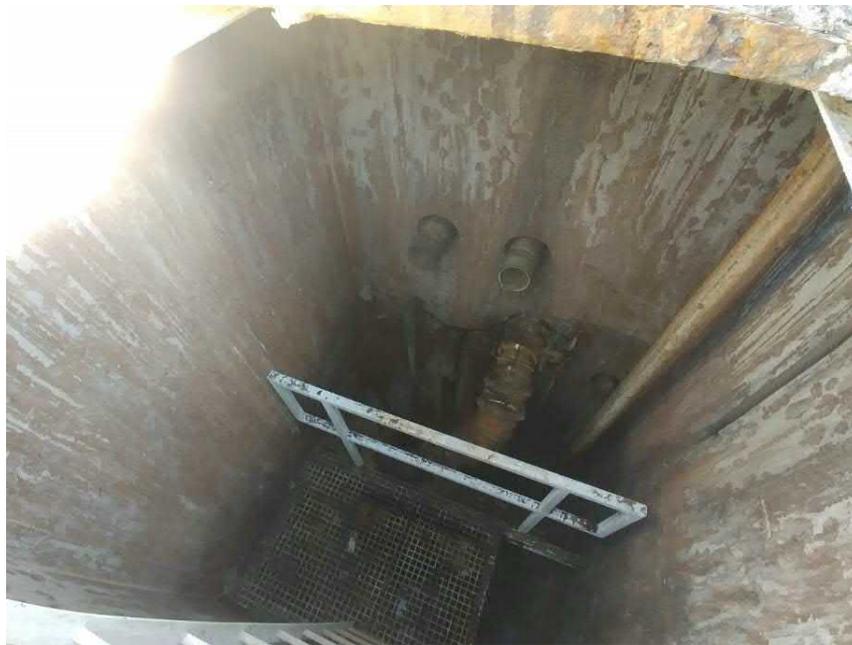
Figure 4.6 – Lift Station Wet Well

The Village may also want to consider improvements to the wet well and dry well ventilation systems. Based on conversations with the operators, when the wet well surcharges above the ventilation lines, wastewater enters the dry well through the lines. The rest of the heating and ventilation system appeared in good condition.

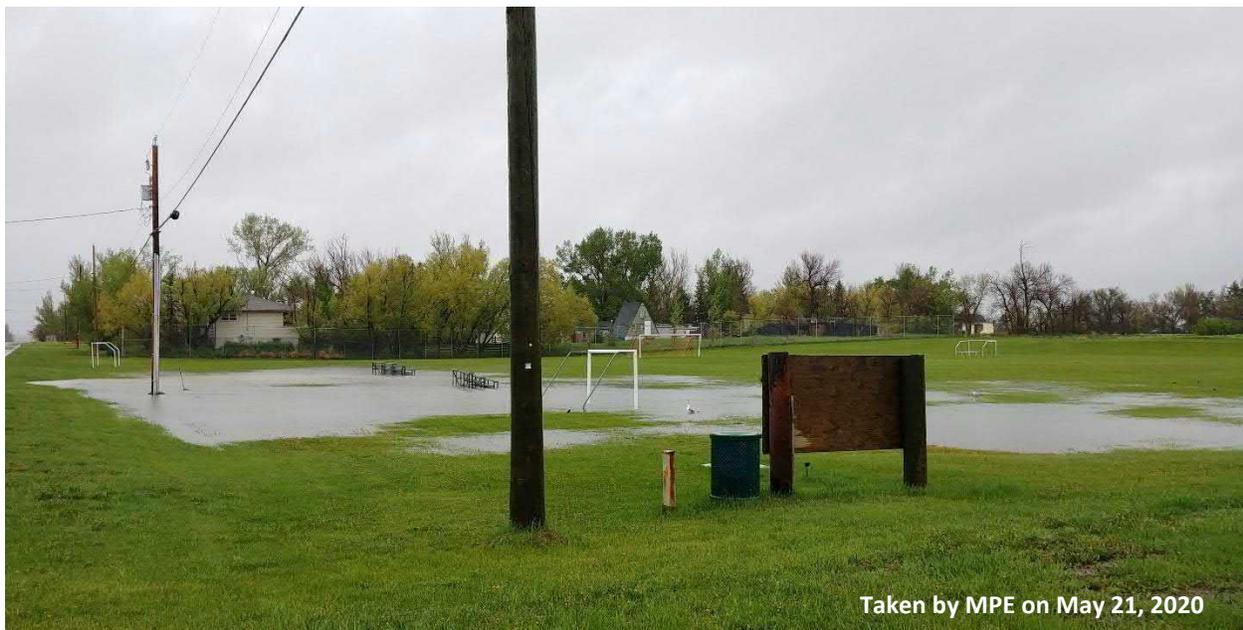
Figure 5.1 – Ponding at Soccer Fields at the Intersection of 2nd Street and 5th Avenue

Throughout the duration of the study, the Village was subject to relatively large storm events which caused localized ponding throughout the Village. The rainfall was not comparable to a major event such as a 1:100-year event, but because it produced a large volume of runoff over 48 hours it provided valuable information for this assessment. Photos throughout the Village and the localized ponding are shown in Figures 5.1 to 5.3. The localized ponding throughout the Village was not a significant concern for Village staff as the existing infrastructure eventually allows for all ponding to drain away without having caused serious flooding in the past.

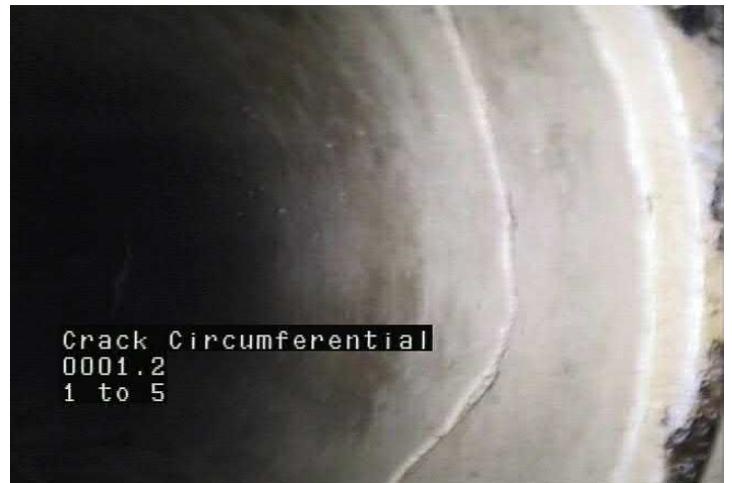
JOM - Joint Offset (displaced): Medium @ 1.2 m.

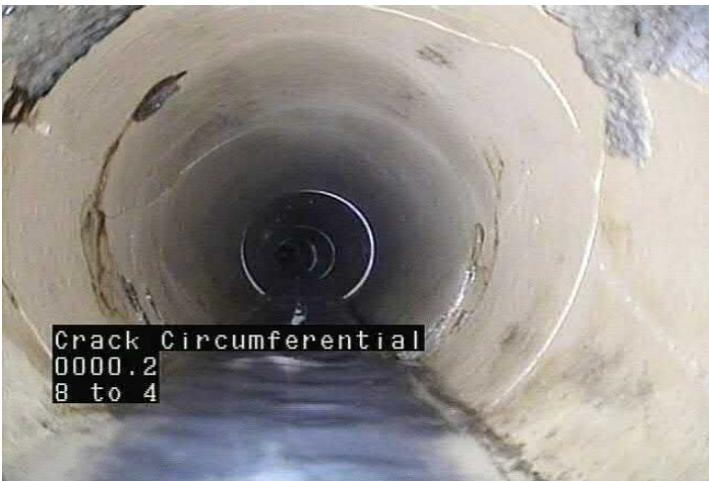
CC - Crack Circumferential @ 0.2 m.

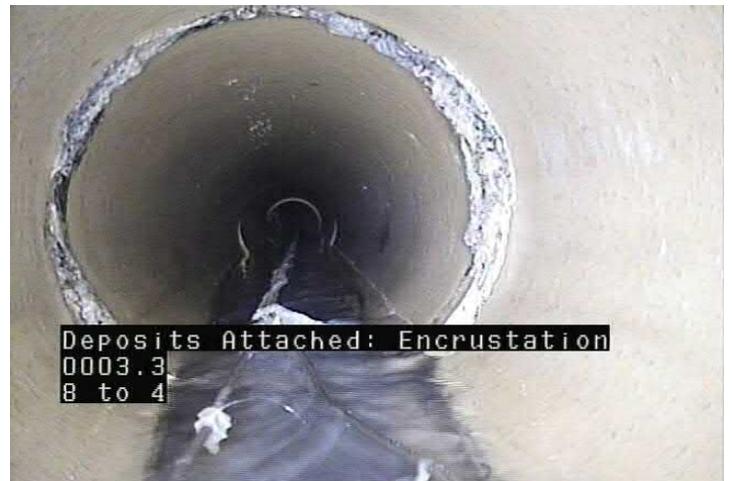
DAE - Deposits Attached: Encrustation @ 3.3 m.

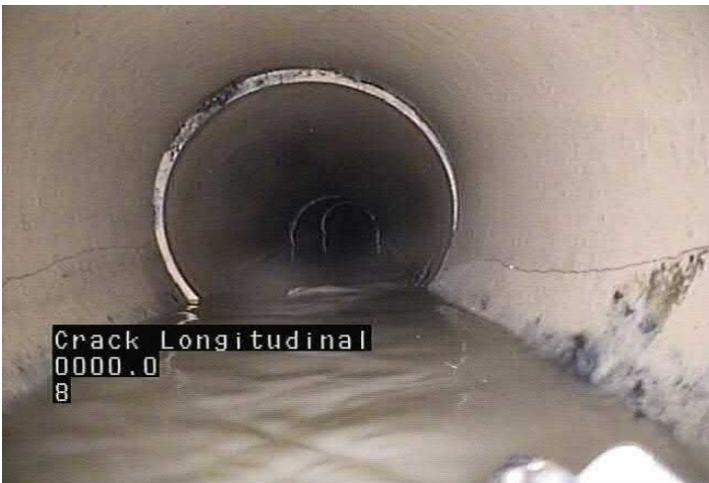
CL - Crack Longitudinal @ 1.0 m.

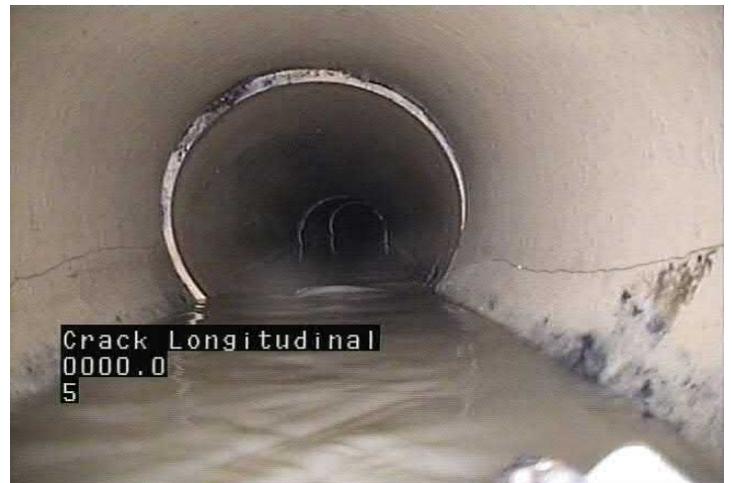
CL - Crack Longitudinal @ 1.0 m.
