VILLAGE OF
STIRLING
NATIONAL HISTORIC SITE

VILLAGE OF STIRLING INFRASTRUCTURE MASTER PLAN

Date: September 15, 2020

Project #: 1407-001-00

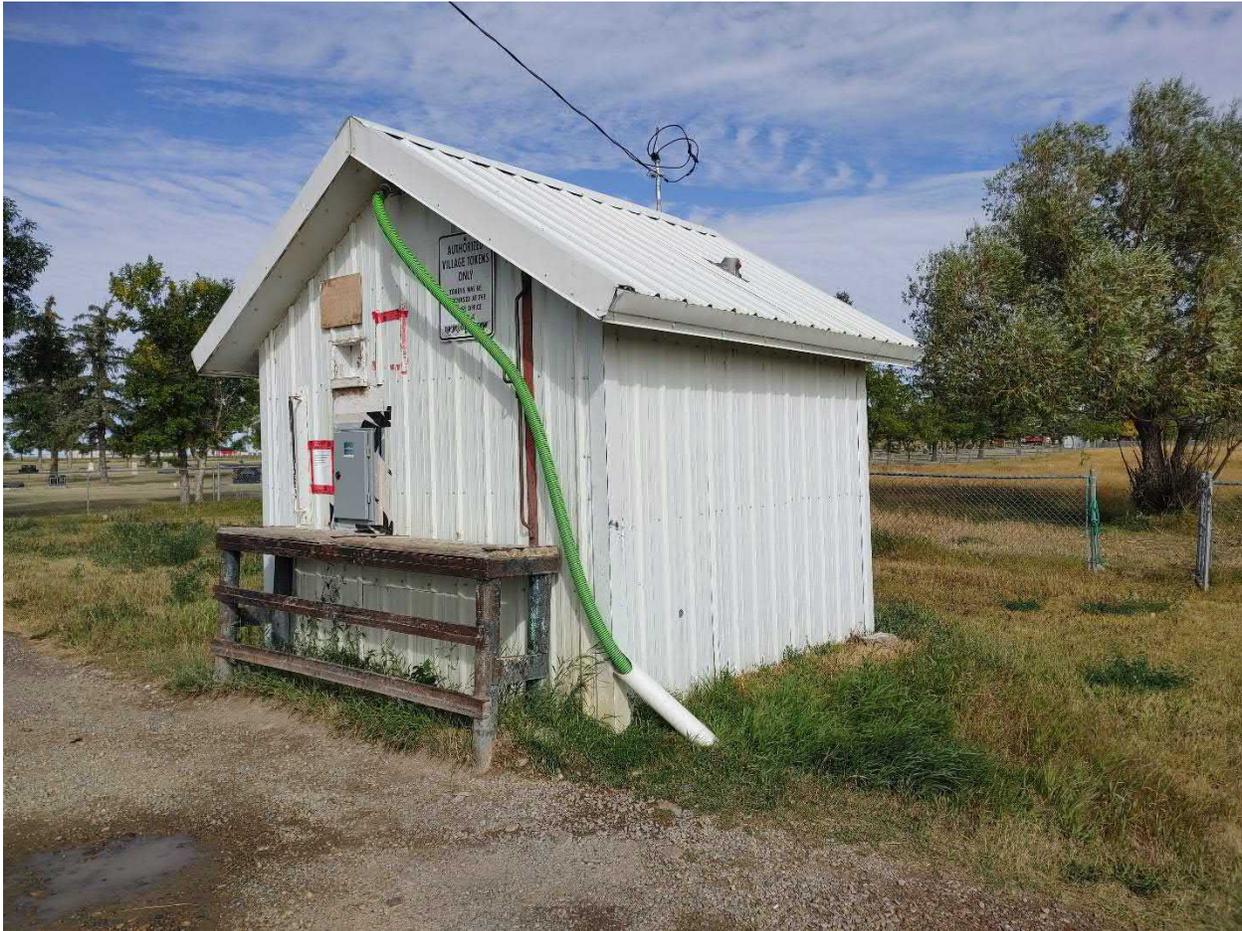
Figure 3.6 – Bulk Fill Station Exterior

The Village operators did not express any concerns with the bulk fill station, and it appeared to be in good condition. No upgrades are recommended for the bulk fill station.

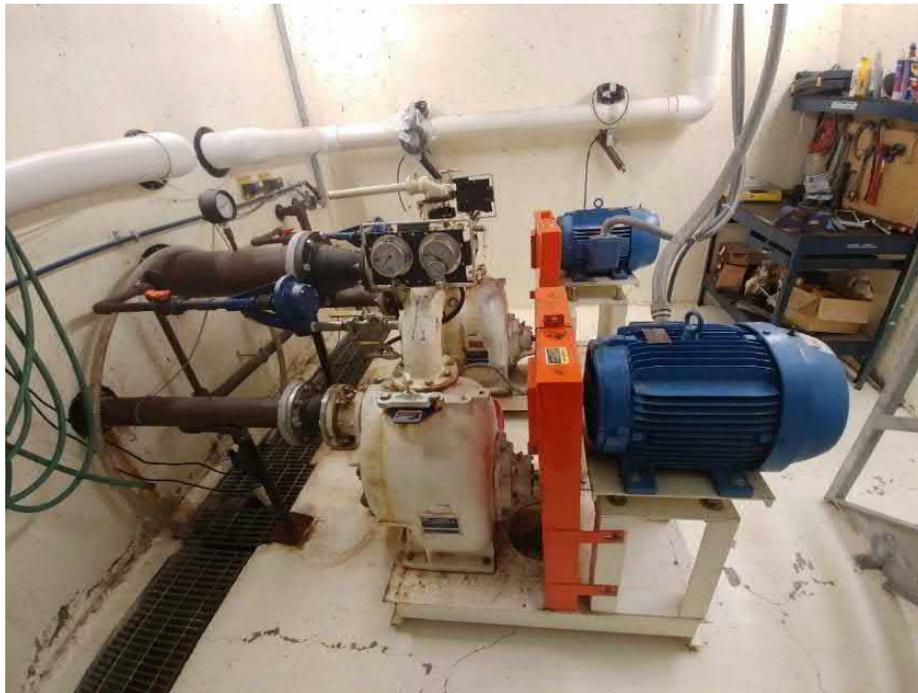
Figure 4.5 – Village Wastewater Lift Station – Pumping Configuration

Overall, the lift station is in good operational condition with the operators having minimal concerns. The Village's operators have scheduled some repair work for 2020 including the following:

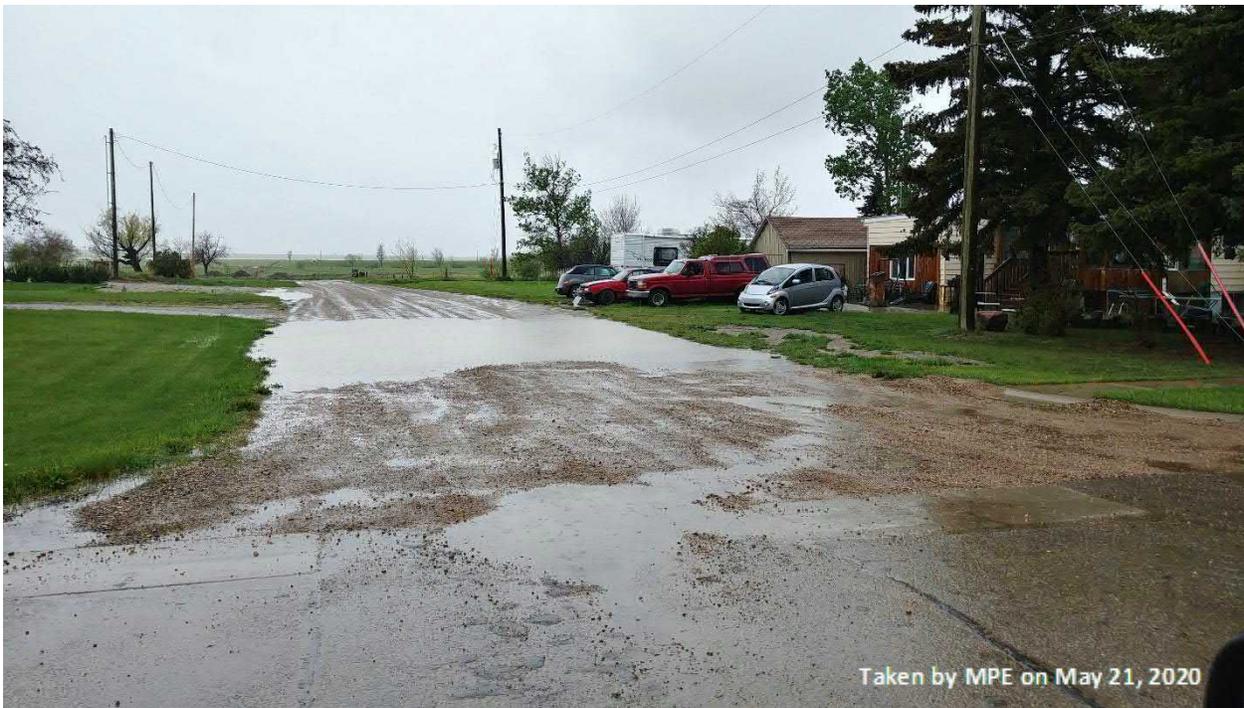
Figure 5.3 – Localized Ponding Near Intersection of 5th Avenue and 5th Street

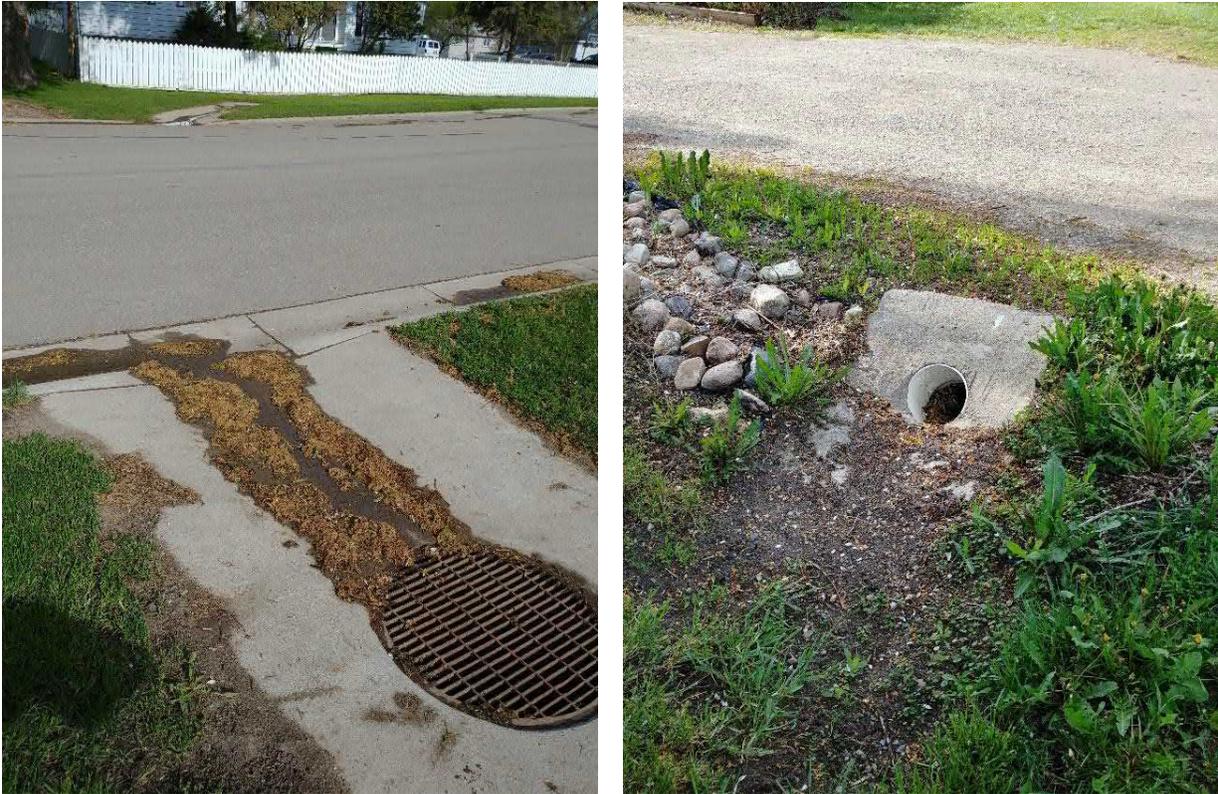
Figure 5.6 – Minor Drainage System Components

CCTV video inspections were not available for the underground piping in the minor drainage system. Like the wastewater collection system, it is recommended that the Village undertake video inspections of the underground piping throughout the storm system to verify its condition. Based on visual site inspections, most of the underground piping is PVC and appeared to be in relatively good condition. The large diameter piping south of 4th Avenue, between 4th Street and the naturally occurring low area does consist of corrugated steel pipe (CSP) and would be a high priority for video inspection to determine its condition.

The Village also noted that the underground piping throughout the school yard does often become blocked with debris, grass clippings, and sediment. These issues could be a result of the relatively shallow slope throughout the piping.

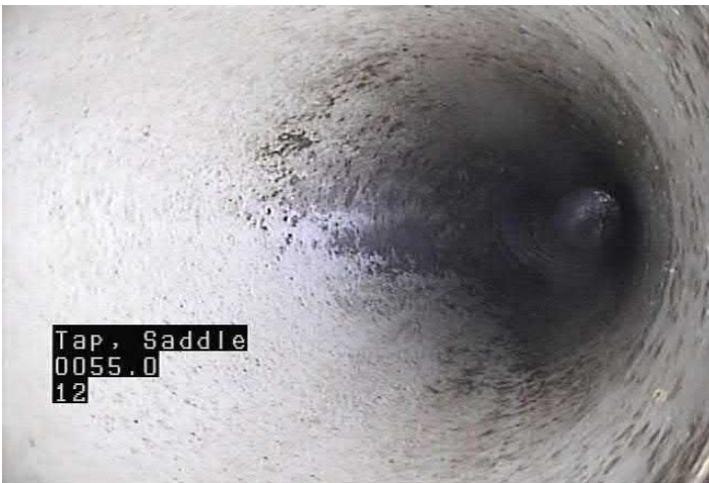
TS - Tap, Saddle @ 55.0 m.

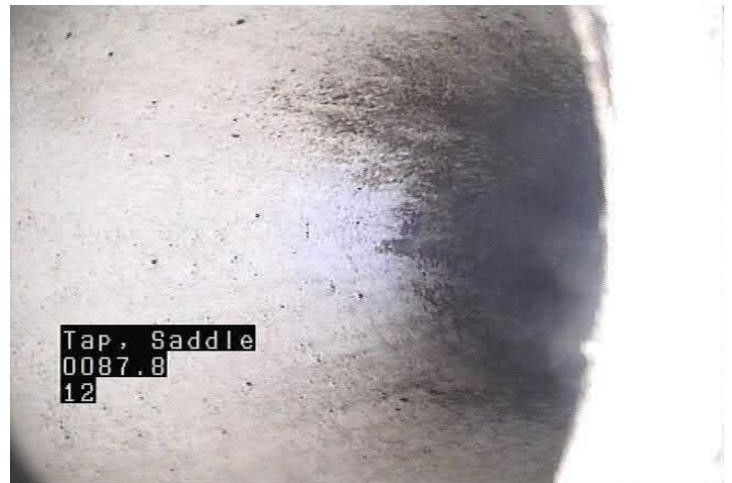
TS - Tap, Saddle @ 87.8 m.

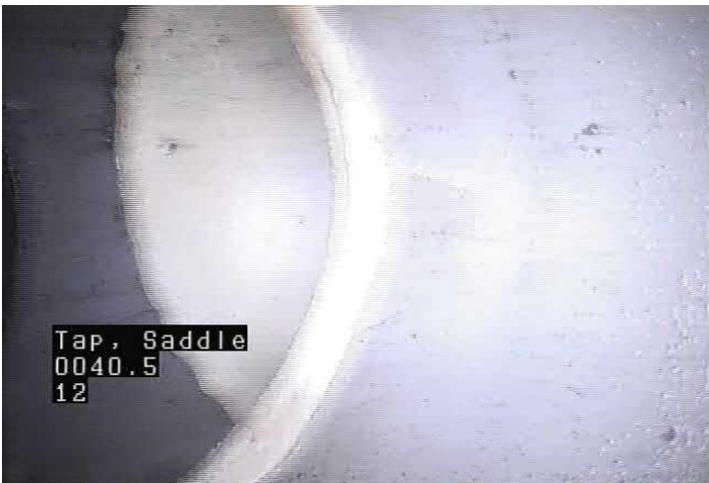
TS - Tap, Saddle @ 40.5 m.

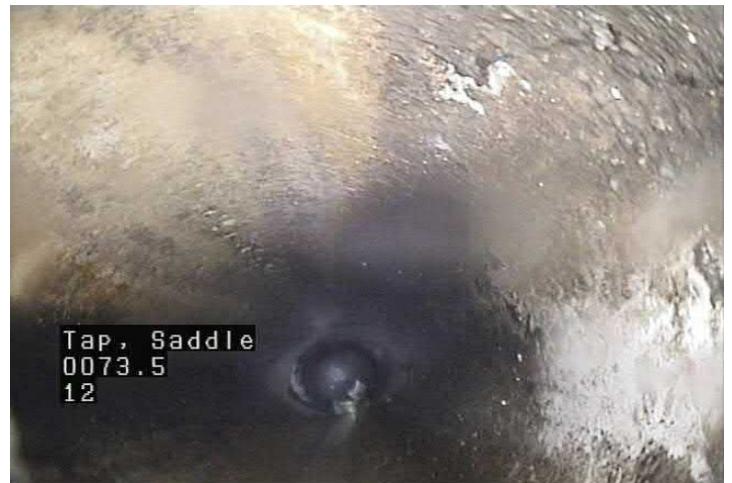
TS - Tap, Saddle @ 73.5 m.

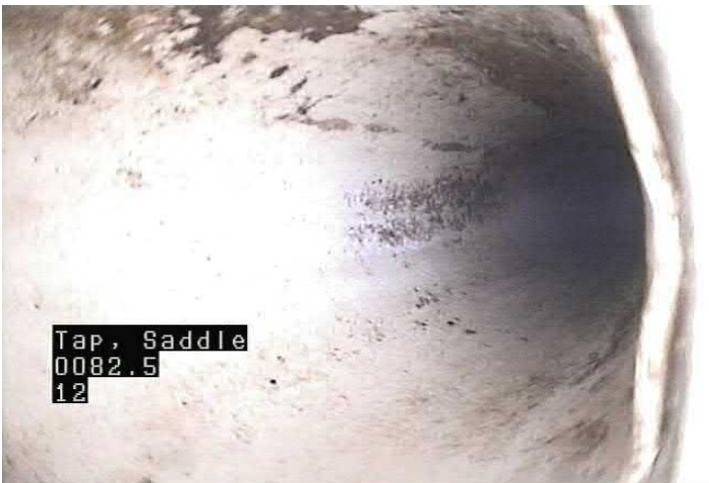
TS - Tap, Saddle @ 82.5 m.

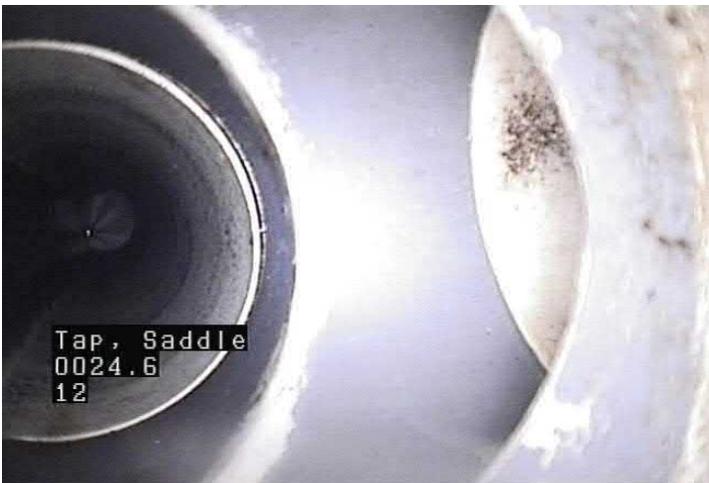
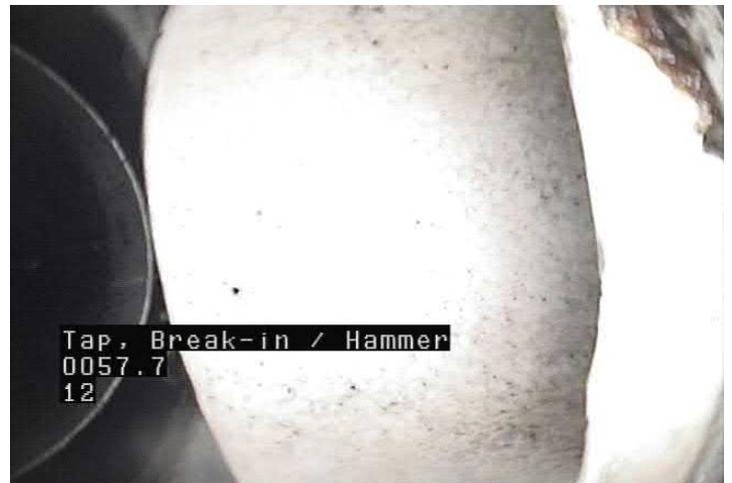
TS - Tap, Saddle @ 24.6 m.

TB - Tap, Break-in / Hammer @ 57.7 m.

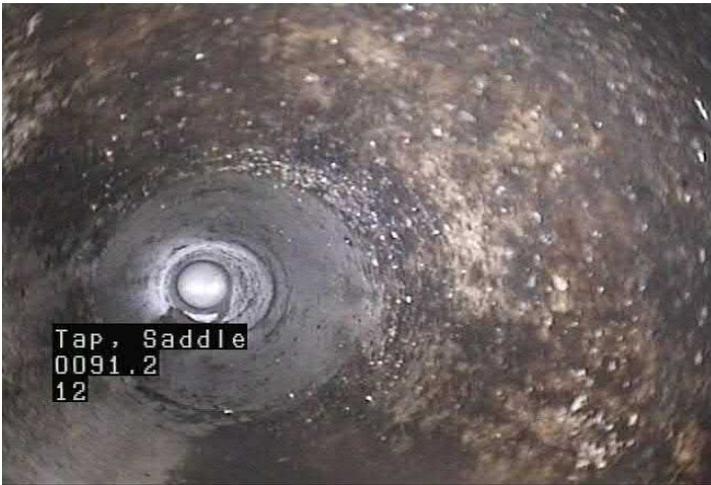
TS - Tap, Saddle @ 91.2 m.

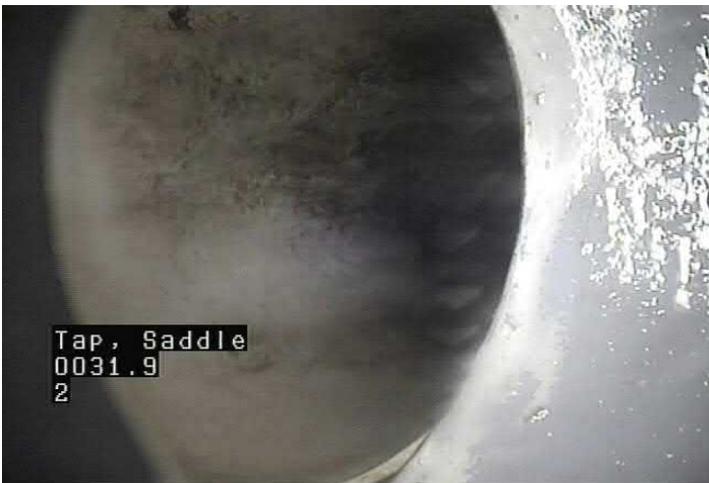
TS - Tap, Saddle @ 31.9 m.

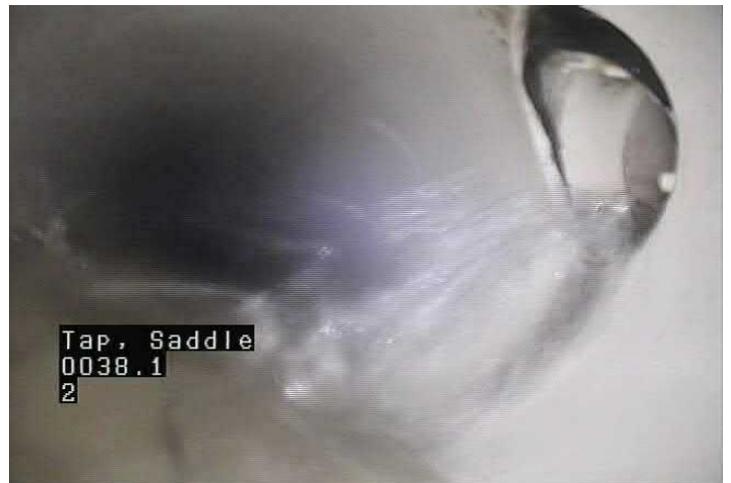
TS - Tap, Saddle @ 38.1 m.

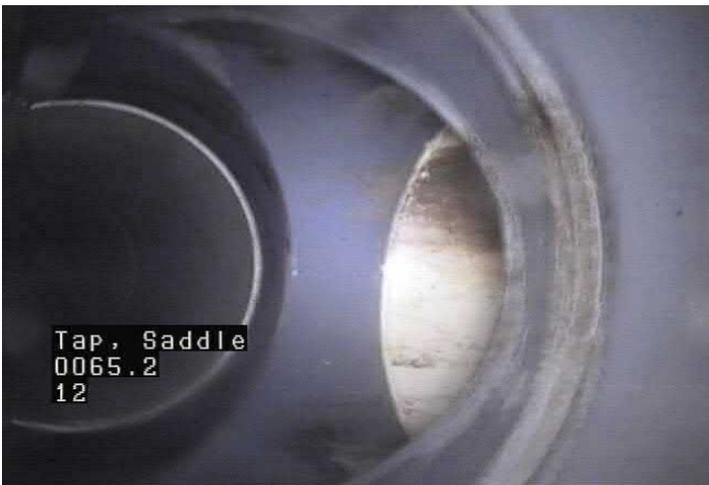
TS - Tap, Saddle @ 65.2 m.

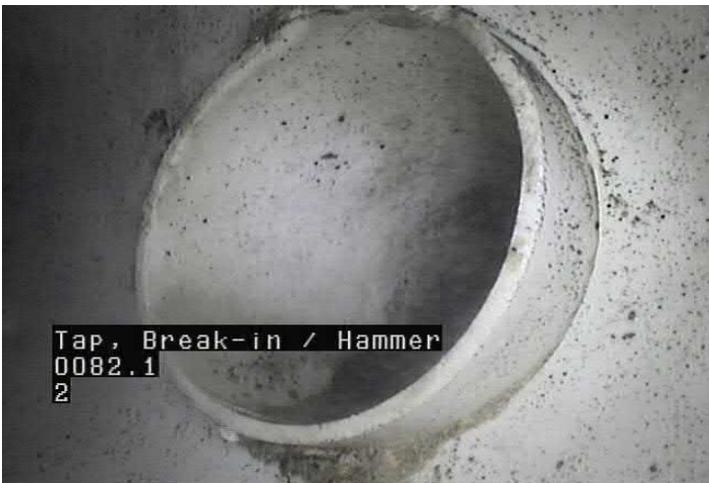
TB - Tap, Break-in / Hammer @ 82.1 m.

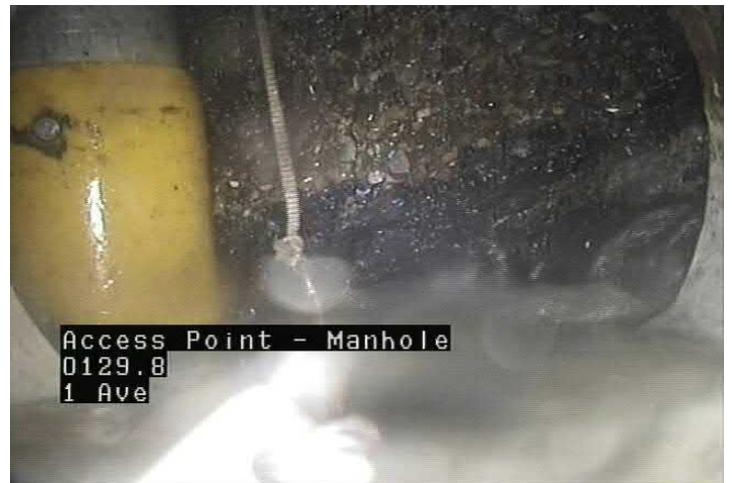
AMH - Access Point - Manhole @ 129.8 m.
 1 Ave

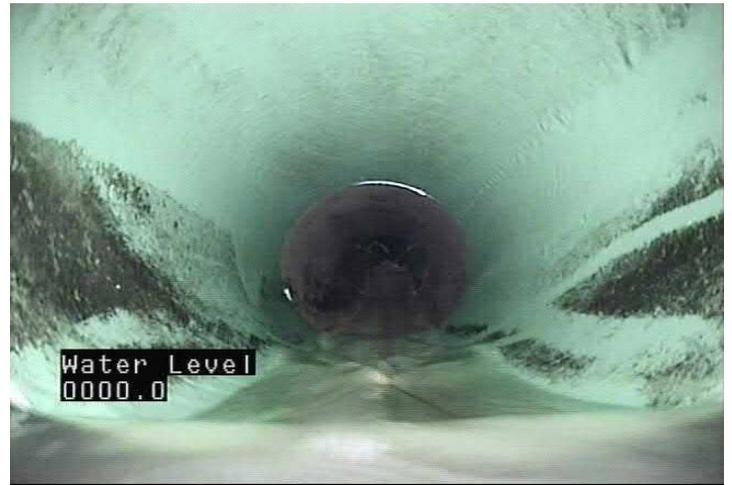
MWL - Water Level @ 0.0 m.

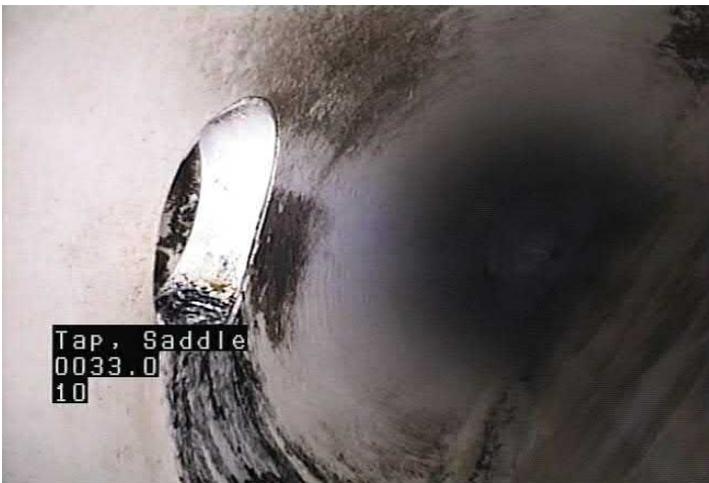
TS - Tap, Saddle @ 33.0 m.

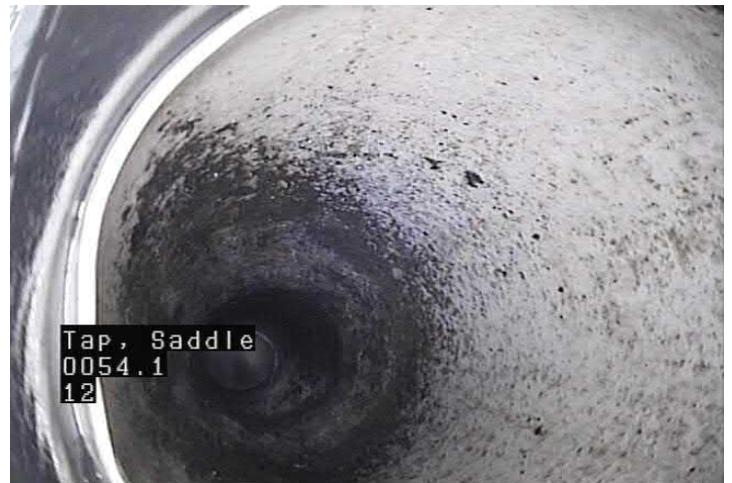
TS - Tap, Saddle @ 54.1 m.

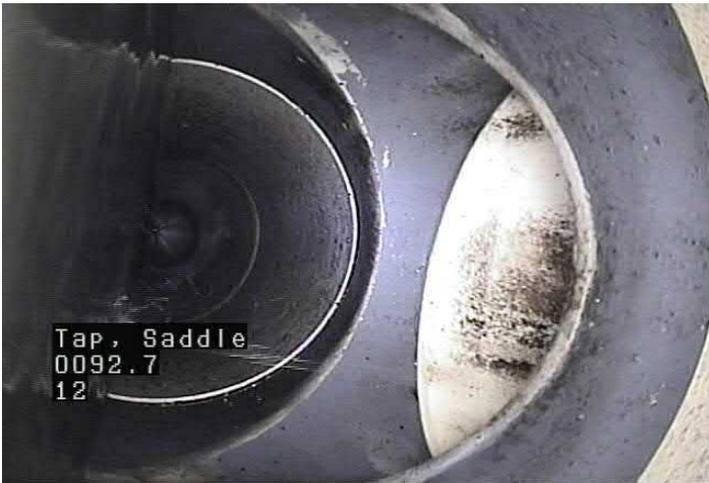
TS - Tap, Saddle @ 92.7 m.

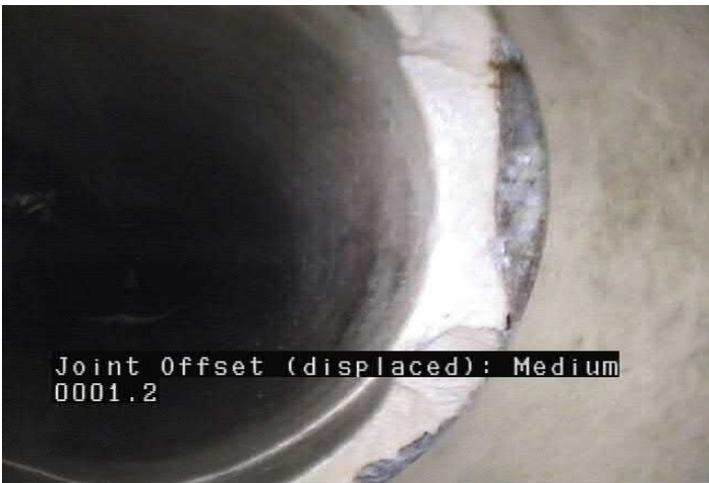
JOM - Joint Offset (displaced): Medium @ 1.2 m.

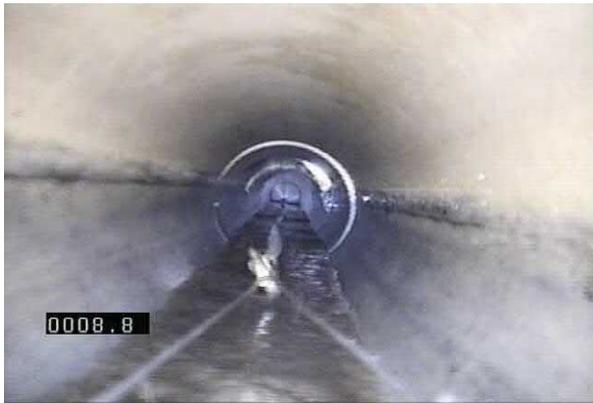
MGO - General Observation @ 8.8 m.
 Visible lines on side of pipe show how much sediment/debris we removed with multiple flushes

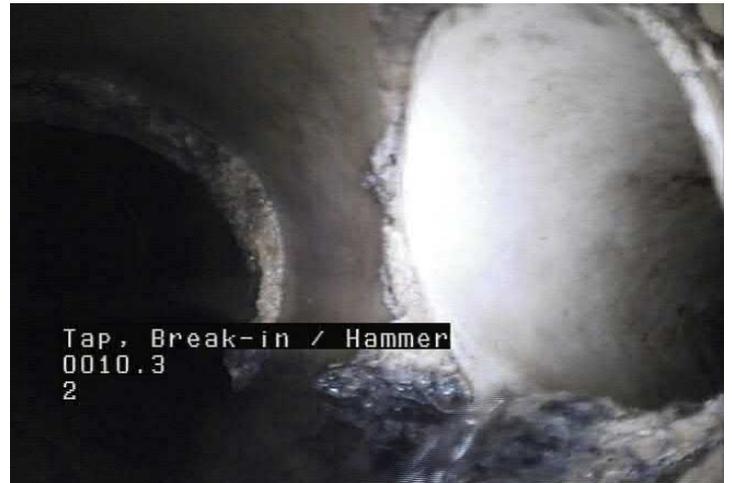
TB - Tap, Break-in / Hammer @ 10.3 m.

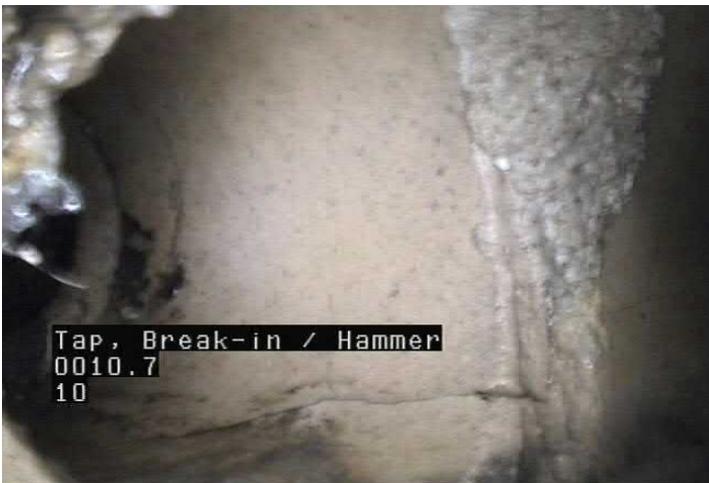
TB - Tap, Break-in / Hammer @ 10.7 m.

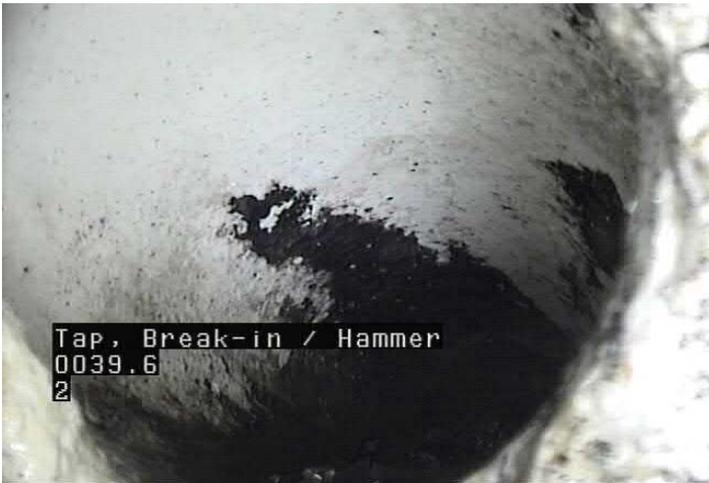
TB - Tap, Break-in / Hammer @ 39.6 m.

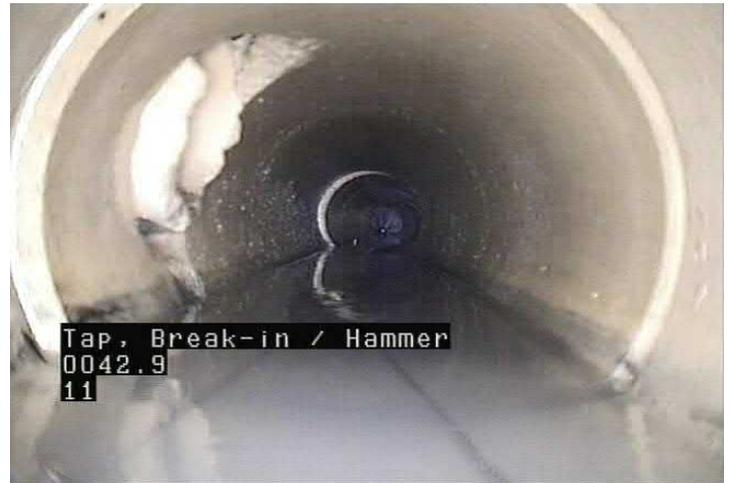
TB - Tap, Break-in / Hammer @ 42.9 m.

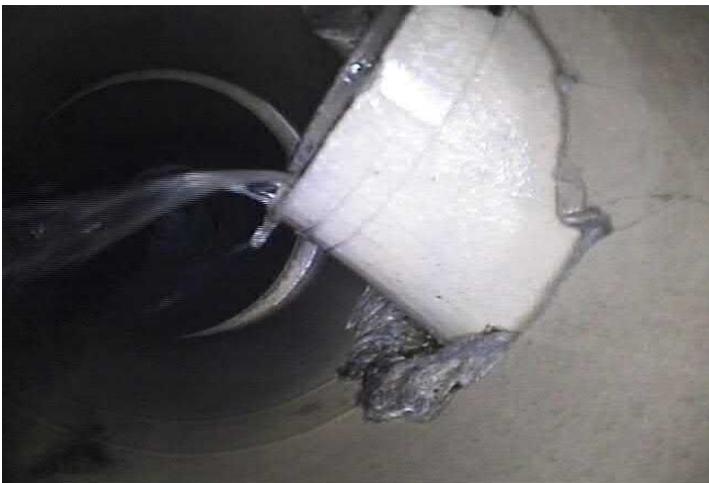
TBI - Tap, Break-in / Hammer: Intruding @ 59.9 m.

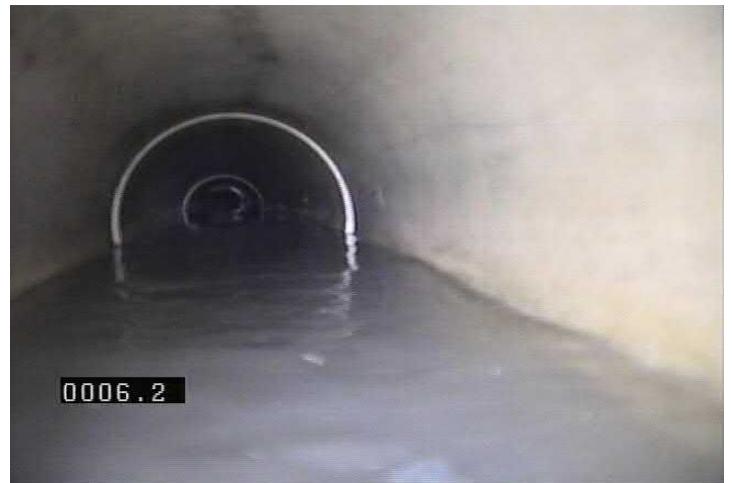
MSA - Survey Abandoned @ 60.0 m. Could not get by intruding service

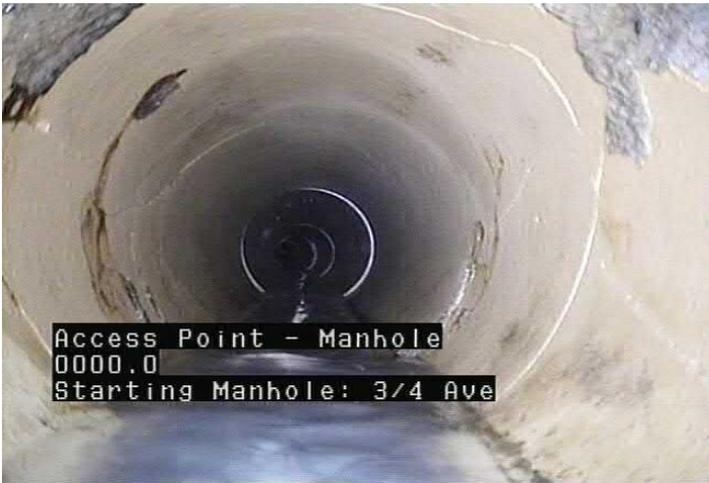
AMH - Access Point - Manhole @ 0.0 m.
 Starting Manhole: 3/4 Ave

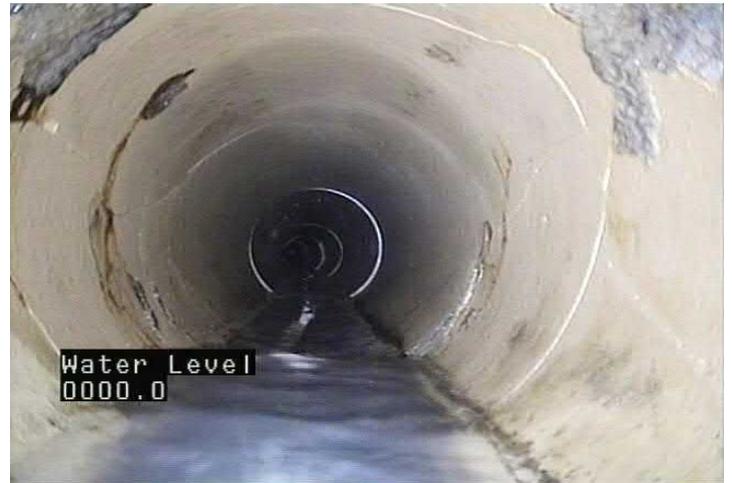
MWL - Water Level @ 0.0 m.

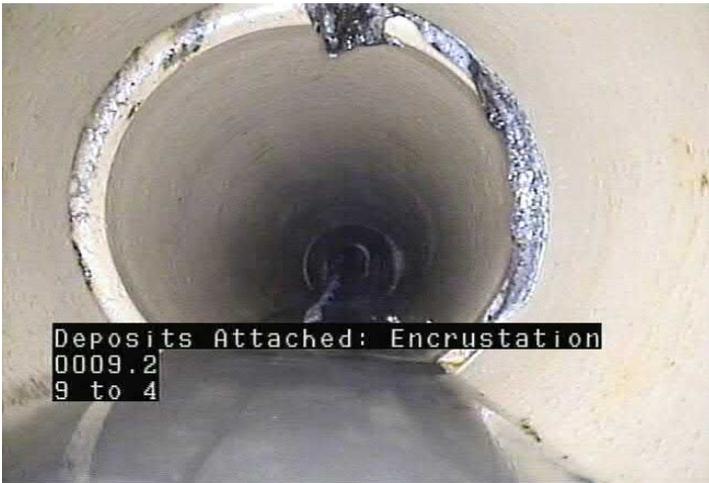
DAE - Deposits Attached: Encrustation @ 9.2 m.

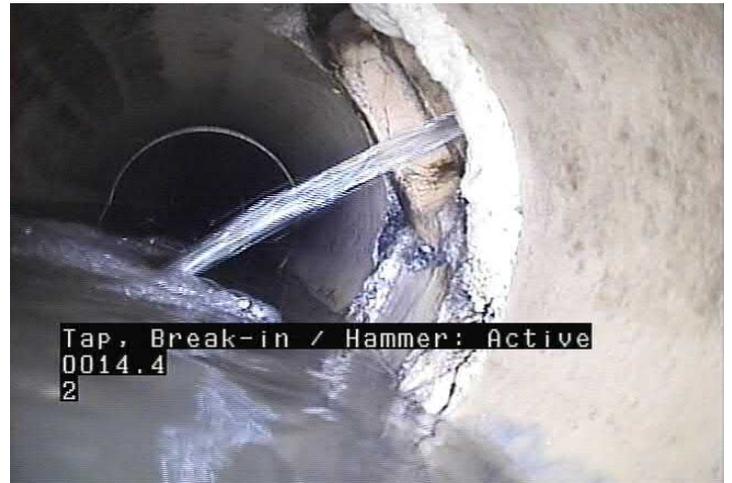
TBA - Tap, Break-in / Hammer: Active @ 14.4 m.

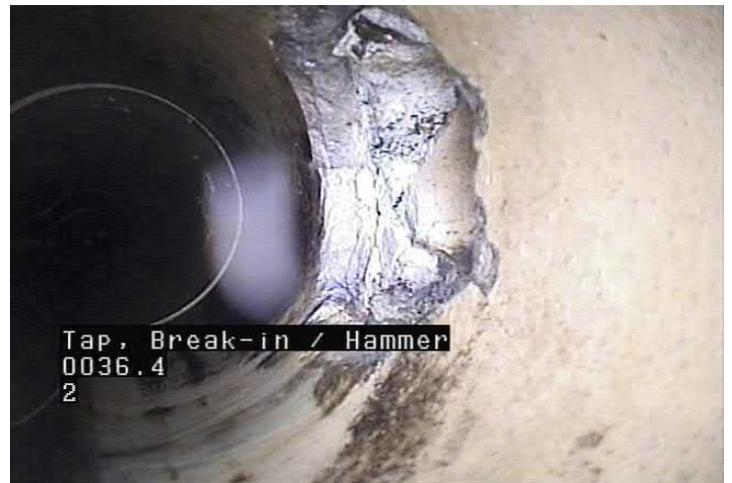
TB - Tap, Break-in / Hammer @ 36.4 m.

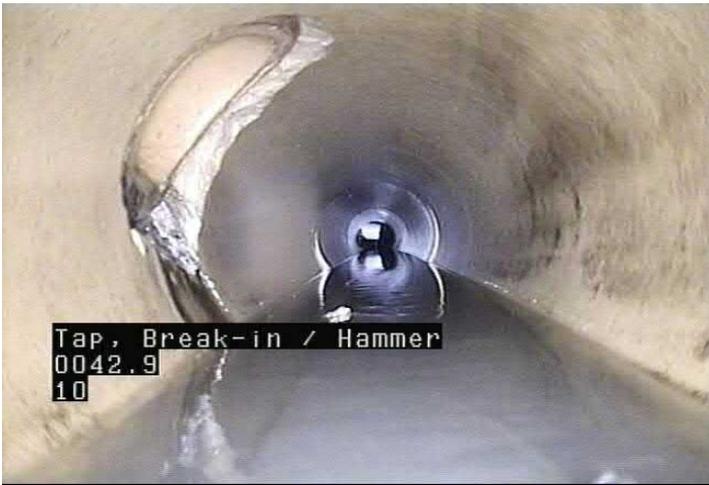
TB - Tap, Break-in / Hammer @ 42.9 m.

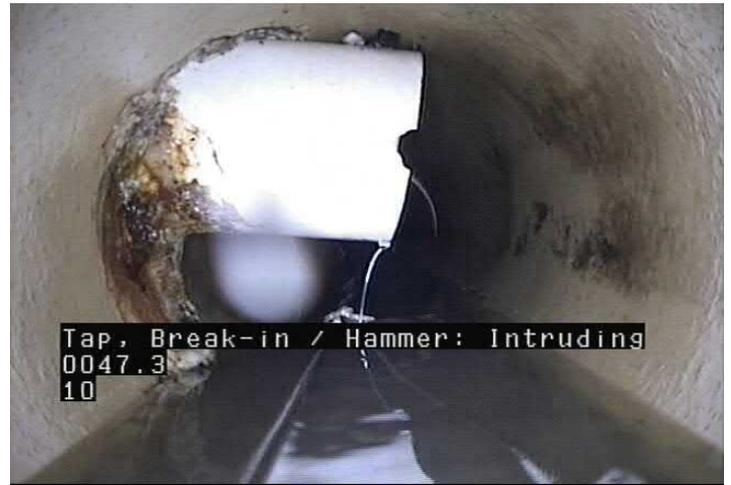
TBI - Tap, Break-in / Hammer: Intruding @ 47.3 m.

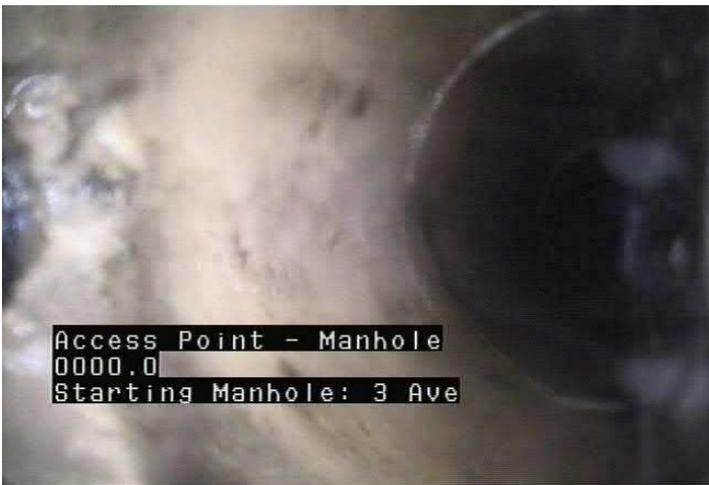
AMH - Access Point - Manhole @ 0.0 m.
 Starting Manhole: 3 Ave

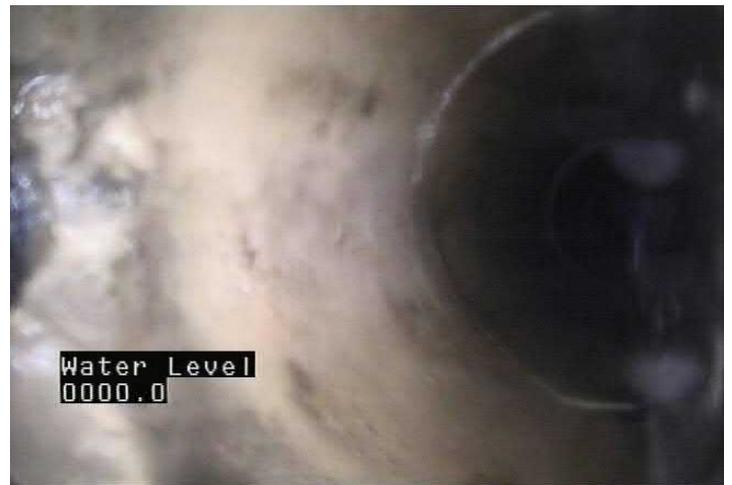
MWL - Water Level @ 0.0 m.

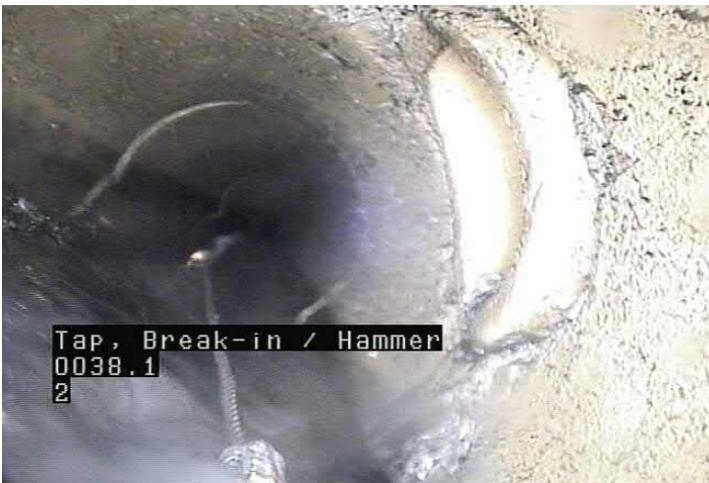
TB - Tap, Break-in / Hammer @ 38.1 m.

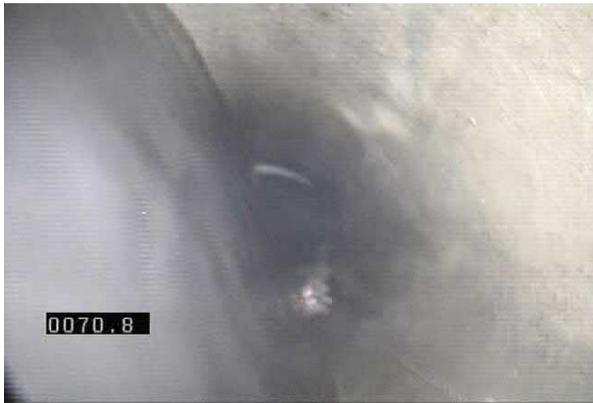
LRU - Line - Right/Up @ 70.8 m. Before the camera flips you can see that the line goes up and tpo the right by the pull line on the top right of the pipe

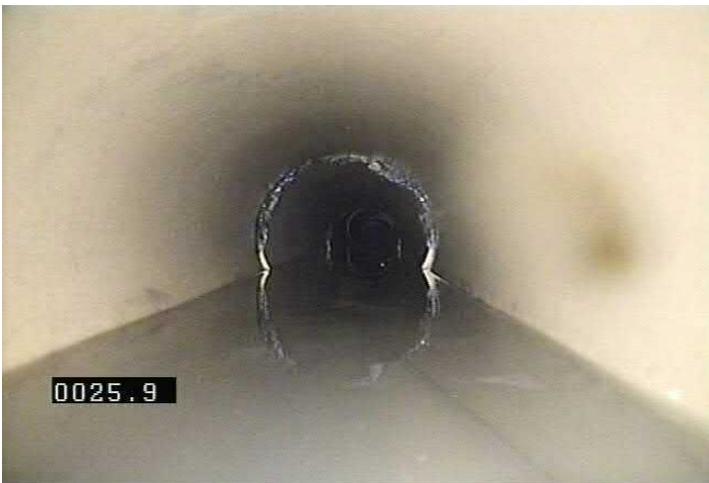
MWLS - Water Level: Sag @ 0.0 m.

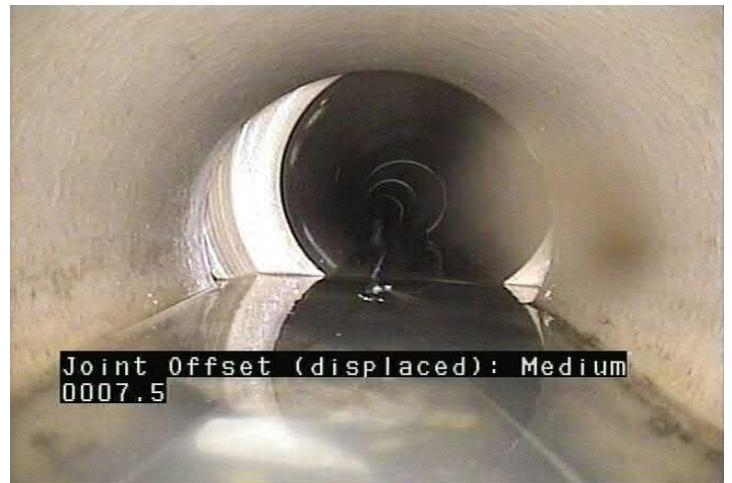
JOM - Joint Offset (displaced): Medium @ 7.5 m.

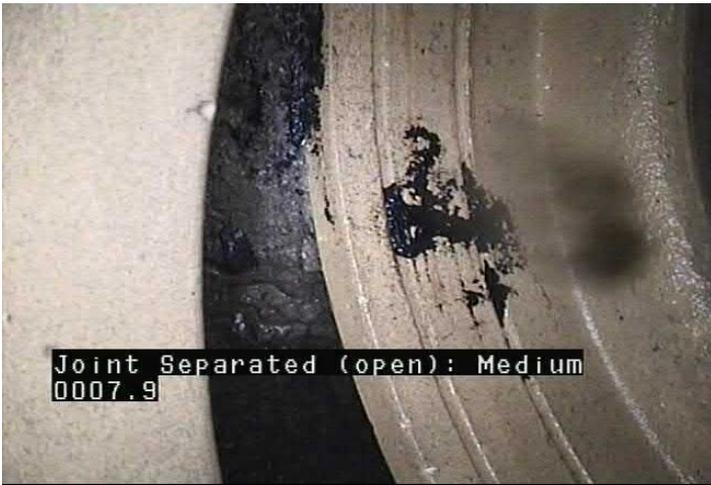
JSM - Joint Separated (open): Medium @ 7.9 m.

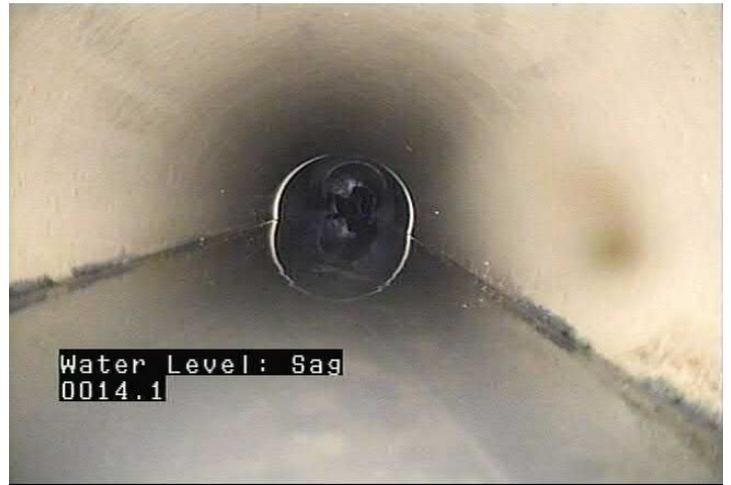
MWLS - Water Level: Sag @ 14.1 m.

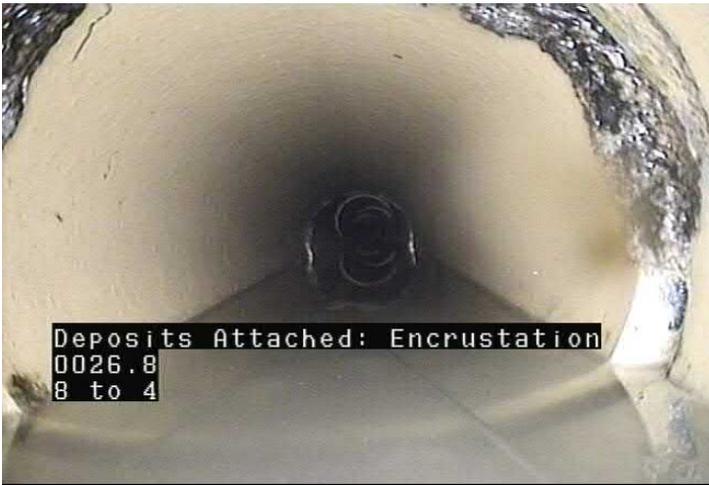
DAE - Deposits Attached: Encrustation @ 26.8 m.

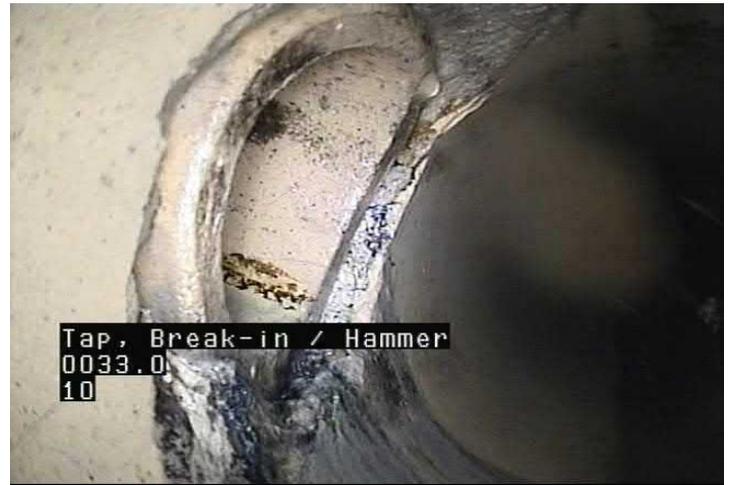
TB - Tap, Break-in / Hammer @ 33.0 m.

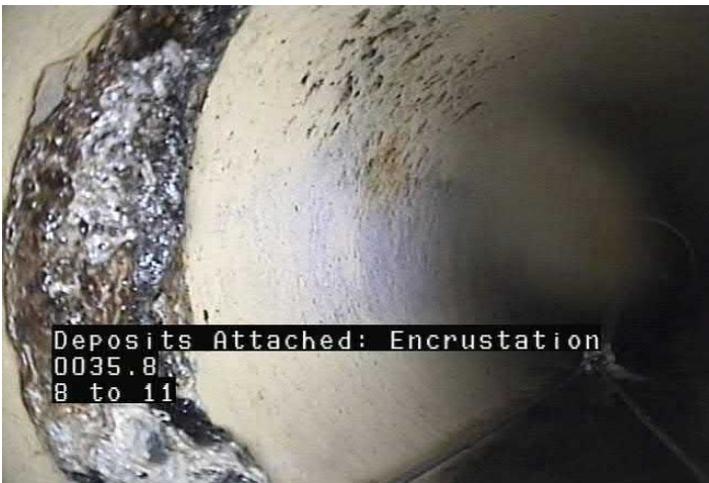
DAE - Deposits Attached: Encrustation @ 35.8 m.

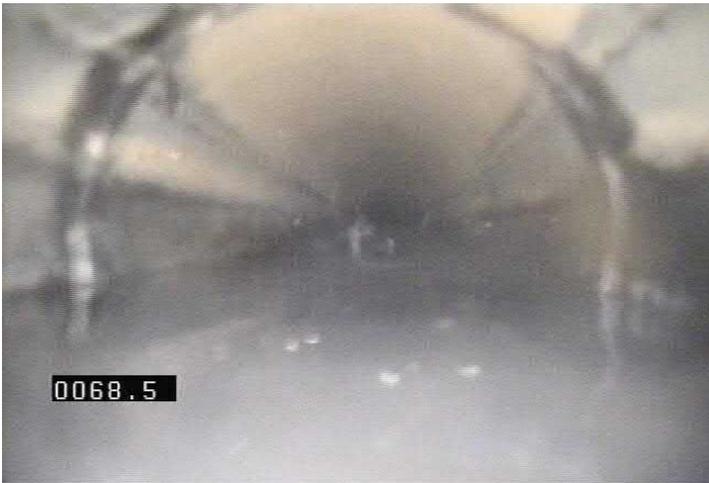
MWM - Water Mark @ 68.5 m. Marks show high water level without out flushing

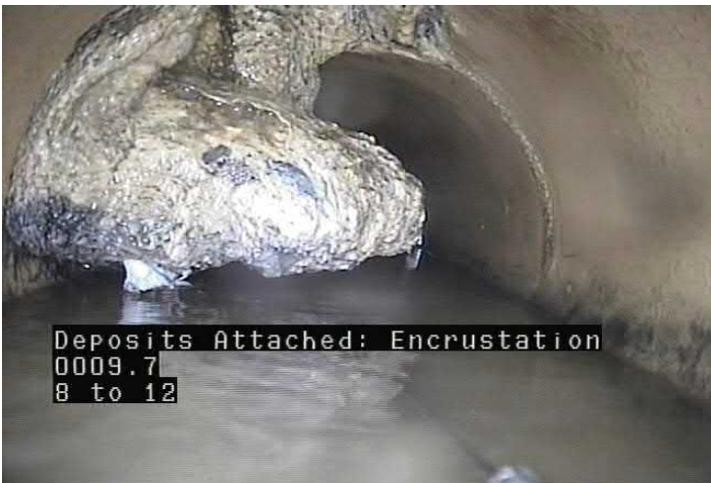
DAE - Deposits Attached: Encrustation @ 9.7 m.
